AERA/AERSCO
AERA Technical Services Department
500 Coventry Lane, Suite 180 Crystal Lake IL 60014
Phone 888/324-2372 Fax 888/329-2372

| | June 2010 TB 2538 | |

Engine Oil Sludge on
1999-2007 Volvo Automotive Engines

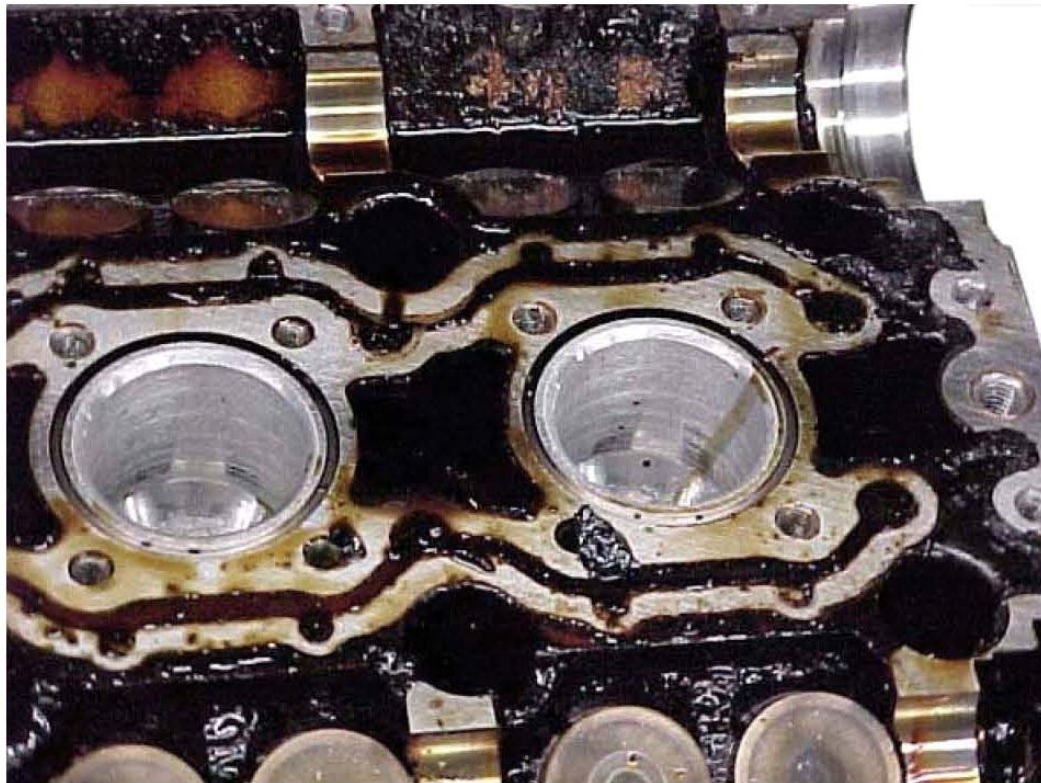
Figure 1 below shows a view of a typical Volvo 2.5L cylinder head once the cylinder head top portion has been removed. Note the burned coloring look of the sludge and casting.

Figure 1. Caked on Oil Sludge

Bulletin Diagram: FIGURE 1. CAKED ON OIL SLUDGE - CYLINDER HEAD

No attempt should be made to clean the cylinder head without first removing it from the engine even if only connecting rod bearings are being installed. During engine assembly it is important to use the following new components to prevent future contamination.

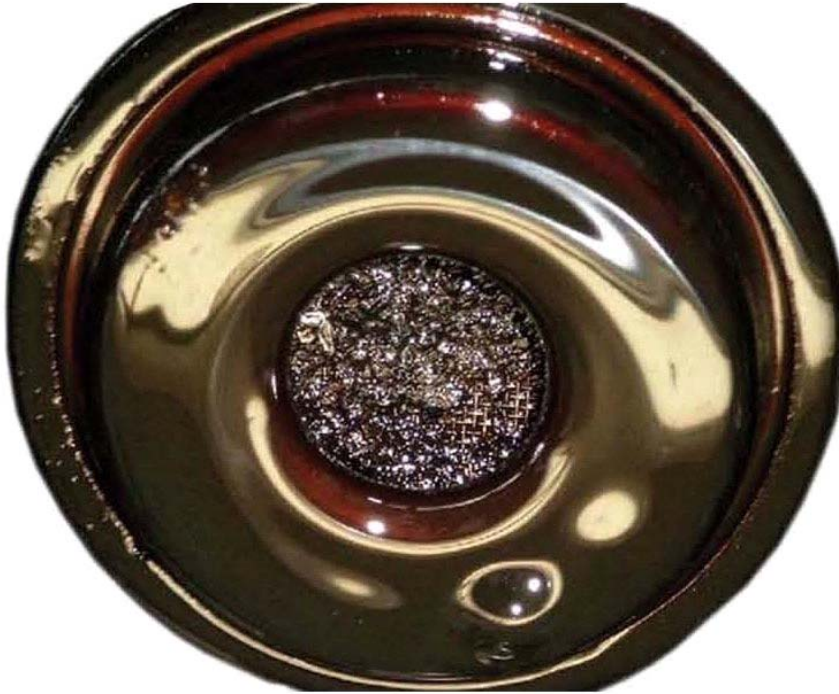
- An illuminated oil pressure lamp on the dash. Due to clogged oil suction strainer

to oil pump and/or oil filter. See Figures 2 & 3.

Figure 2. Clogged Pick Up Screen

Bulletin Diagram: FIGURE 2. CLOGGED OIL PICK-UP SCREEN - FAILURE ANALYSIS

Check the suction strainer on the oil suction line for contaminants and deposits.

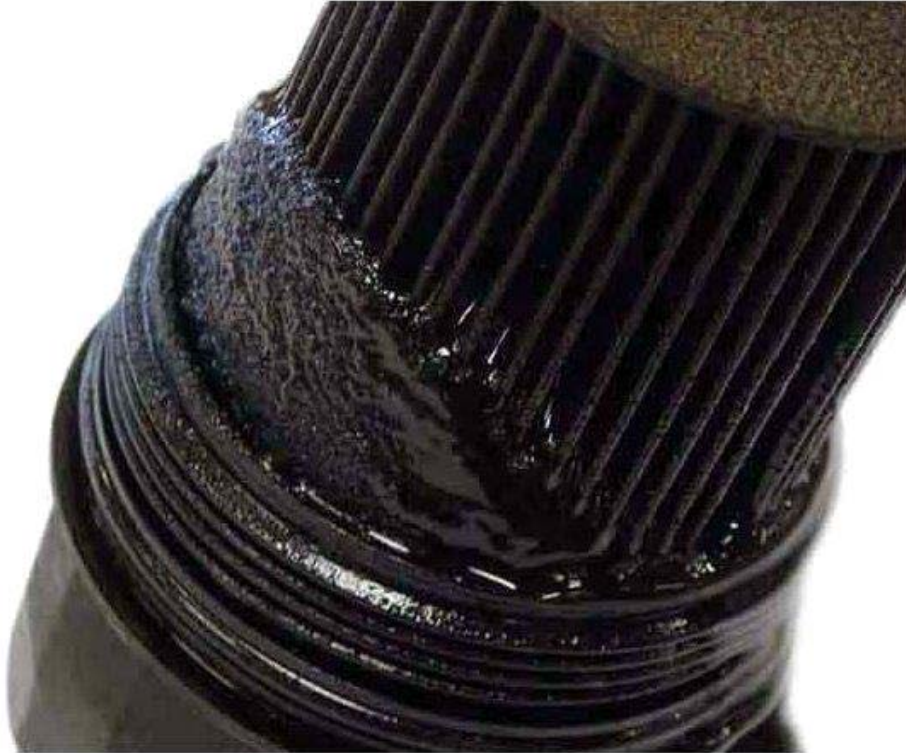
Figure 3. Sludge in Oil Filter

The first step is to inspect the oil filter to see if it is abnormally dirty as shown in Figure 3.

An abnormally dirty filter is easily recognized by its thick, black deposits. Engines with spin-on oil filters can be inspected by sawing the filter in half.

Bulletin Diagram: FIGURE 3. ACCUULATED SLUDGE IN THE OIL FILTE - FAILURE ANALYSIS

Clean the oil filter casing and install the new oil filter. Fill with new Synthetic Oil; this will assist in continuing the cleaning process. ACEA A1/B1, viscosity SAE 5W-30.

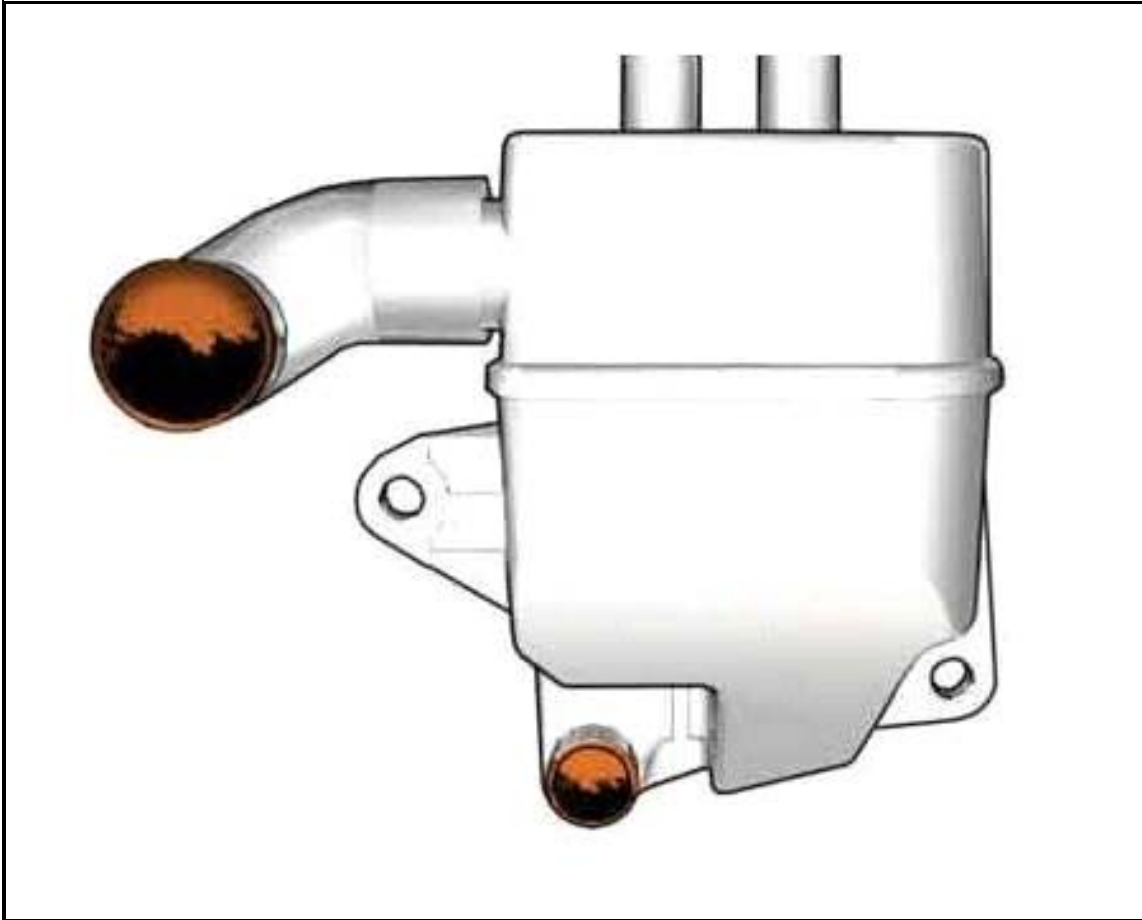
If the engine has a problem with carbon deposits, the passageways in the engine block and oil trap may be completely or partially clogged. See Figure 4. Remove and check the oil trap, hoses and their passageways in the engine block. There should not be any major collections of carbon deposits in the hoses or in the passageways in the block.

Figure 4. Restricted Oil Trap

Bulletin Diagram: FIGURE 4. SEVERELY RESTRICTED OIL TRAP - FAILURE ANALYSIS

Clean the engine block passageway from the oil trap and the oil trap passageway in the block. Use a screwdriver or similar small scraping tool and blow the passageways clean with compressed air. Perform a general cleaning of the crankcase to remove all the carbon deposits. All loose deposits must be thoroughly cleaned no matter what repair method is being attempted.

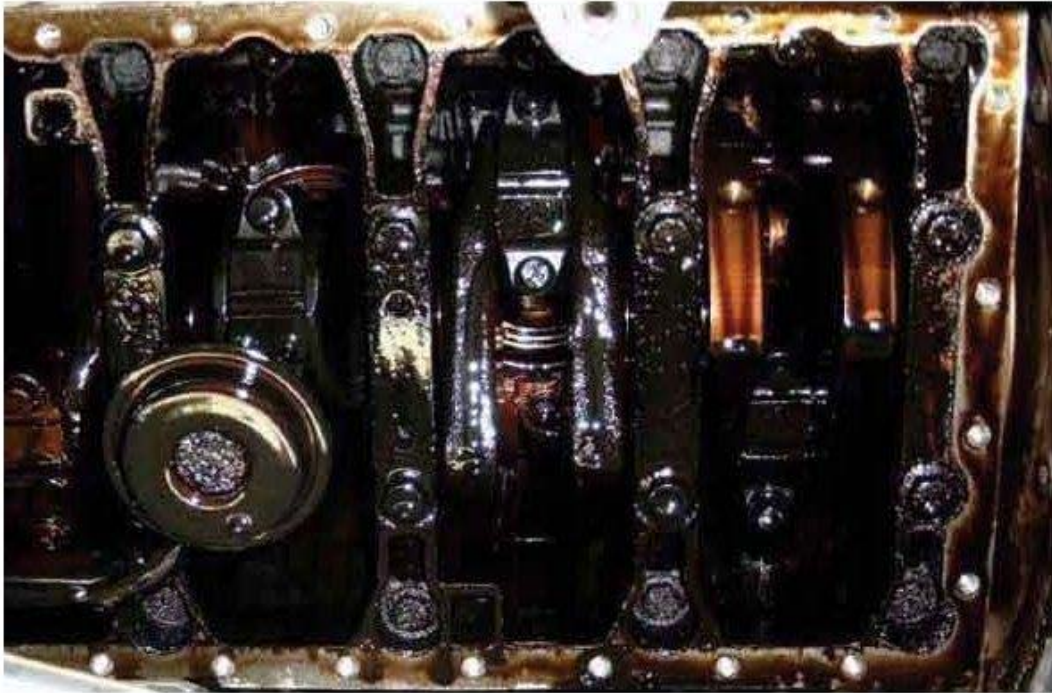
Drain the engine oil. Remove the oil sump and check the oil sump and crankcase for deposits. Normally, there should not be any deposits such as in Figures 5 & 6. A slight light brown discoloration is however normal.

Figures 5& 6. Heavy Oil Sludge Deposits

The figures shown in Figures 5 & 6 depict an engine with heavy deposits.

Bulletin Diagram: FIGURE 5. HEAVY OIL SLUDGE DEPOSITS - FAILURE ANALYSIS

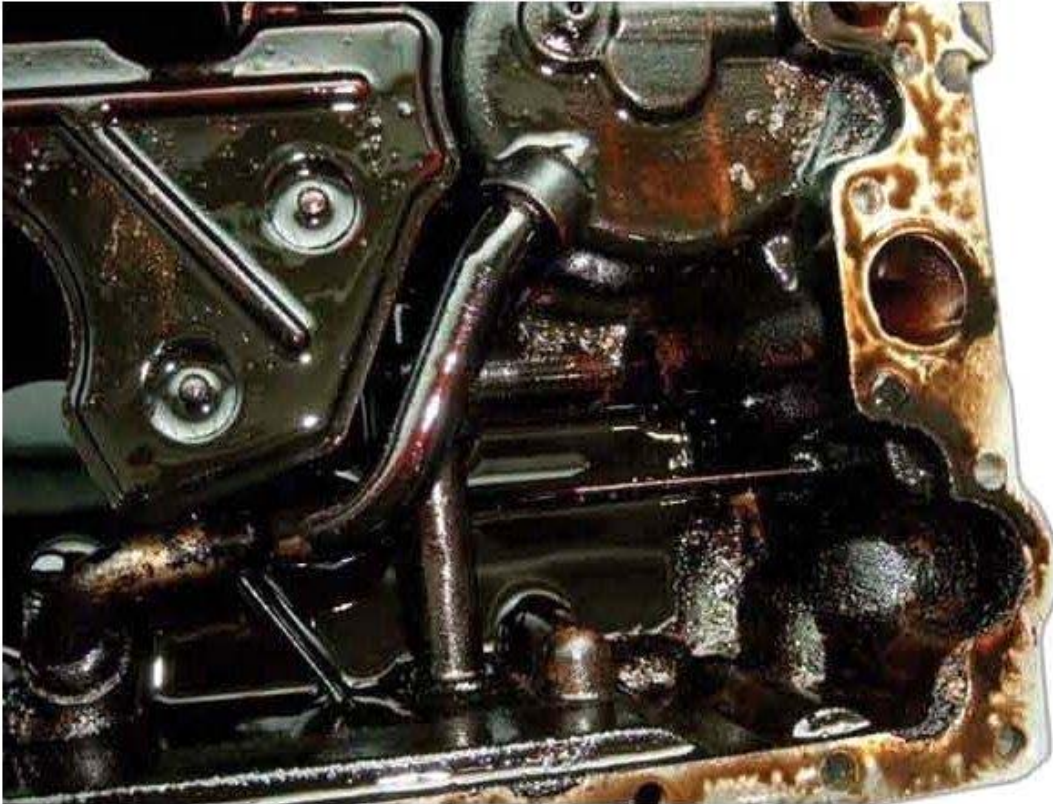
Figure 6.

Bulletin Diagram: FIGURE 6. HEAVY OIL SLUDGE DEPOSITS - FAILURE ANALYSIS

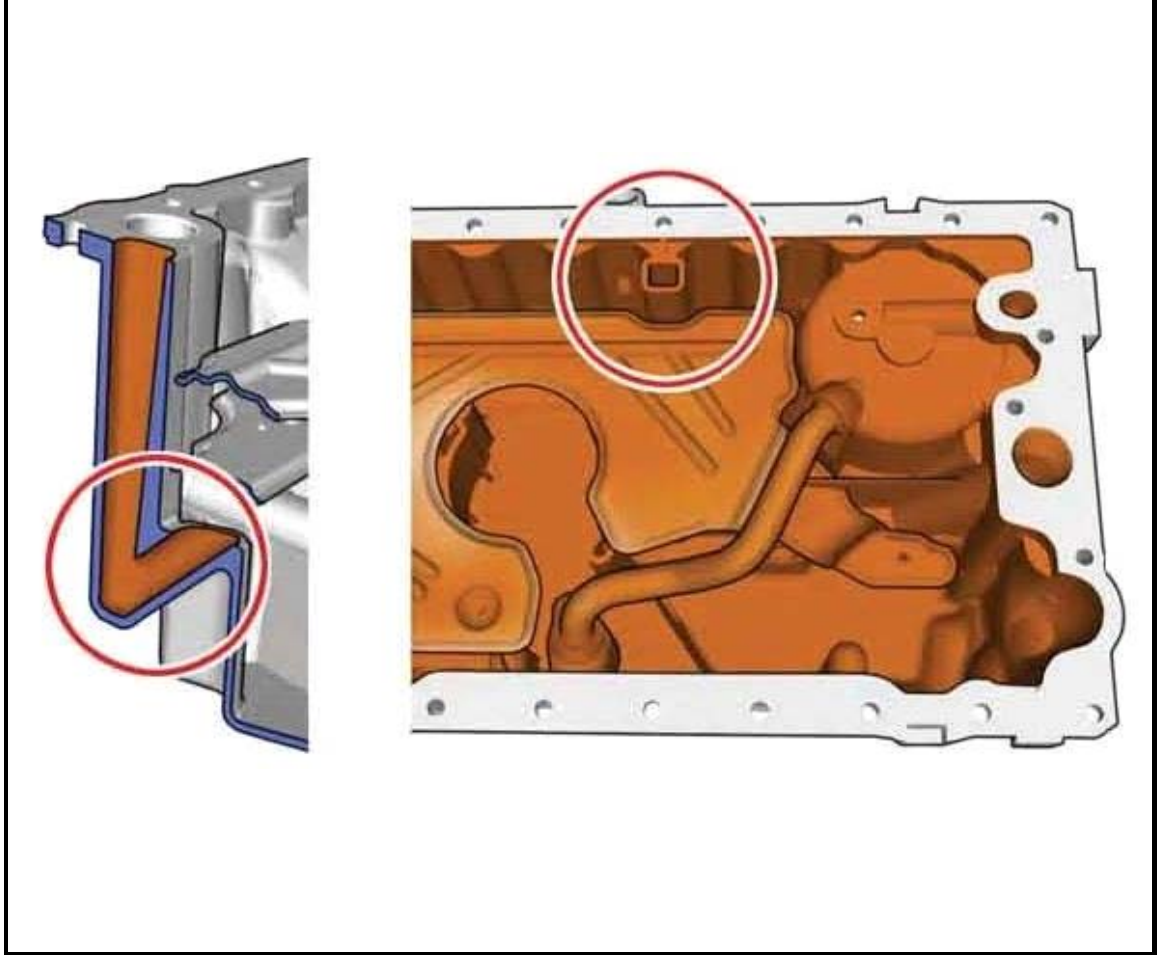
Figure 7 & 8. Oil Sump passages Figure 8.

Bulletin Diagram: FIGURE 7. OIL SUMP PAASSAGES - FAILURE ANALYSIS

Clean the inside of the oil sump by removing any loose deposits before reinstalling it on any engine. Note! Make sure that the oil sump passageway from the oil trap is fully cleaned. See illustration. Blow clear with compressed air to ensure the duct is thoroughly cleaned. Then clean the oil sump as described in the next step. If it is not possible to properly clean the oil sump, oil sump replacement should be considered.

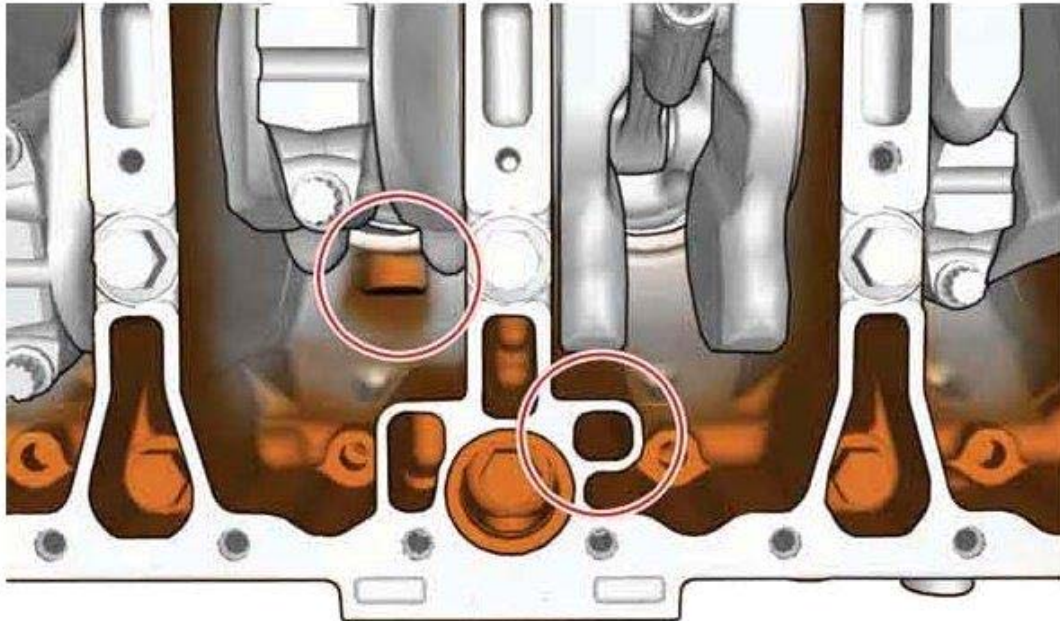
Bulletin Diagram: FIGURE 8. OIL SUMP PASSAGES - FAILURE ANALYSIS

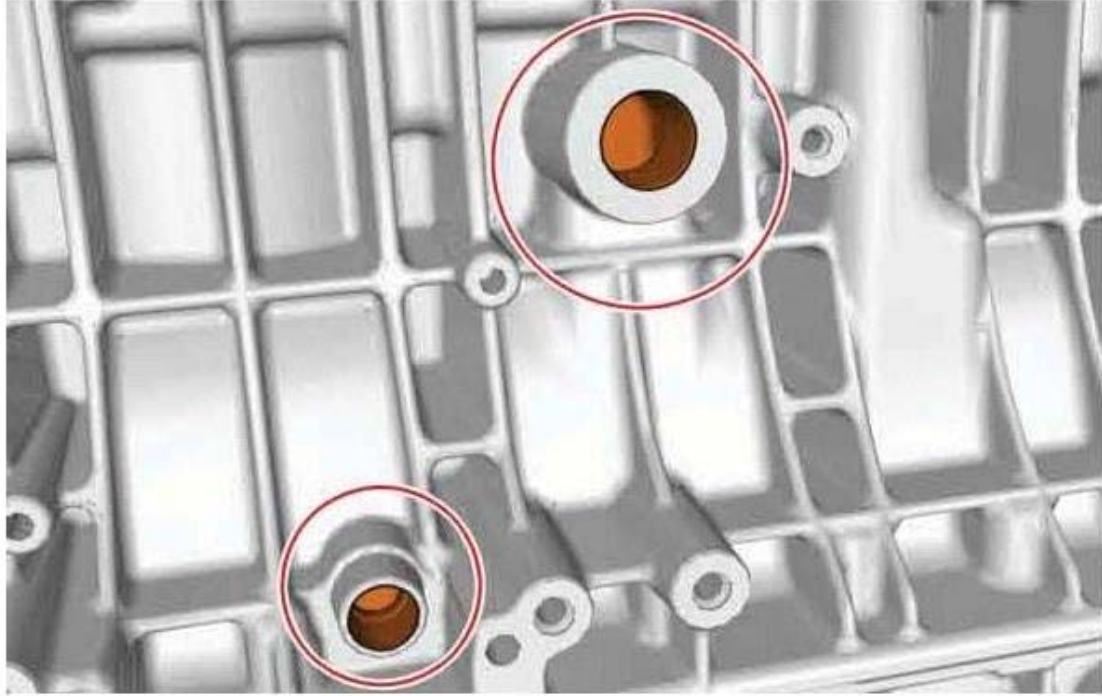
Figure 9. Block oil passage traps

Bulletin Diagram: FIGURE 9. CYLINDER BLOCK OIL PASSAGE TRAPS - FAILURE ANALYSIS
